THE CAT RESOURCE CENTER

Hurricane Milton Implications October 9, 2024

Historic West Coast Florida Landfall Tonight

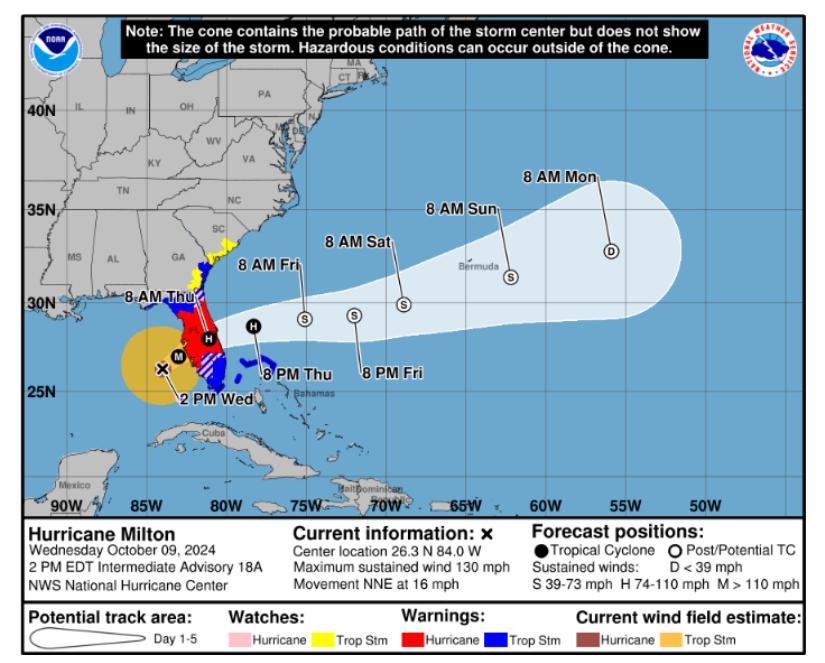
2PM Wednesday October 9th NHC forecast. Source: National Hurricane Center.

- Wind: The forecasted landfall intensity of Milton is between 100-120 knots (~115-135 mph). Maximum recorded gusts could exceed 155 mph at coastal locations. The southeast portion of the storm contains the strongest winds. The highest confidence region of landfall is Manatee and Sarasota County, south of Tampa Bay.

- Storm Surge: The forecasted maximum storm surge of Milton is 10-15 feet and the location of peak surge is currently forecasted for the Florida coastline between Sarasota and Port Charlotte (the region southeast of Milton's forecasted landfall location). Coastal communities in Sarasota, Charlotte and Lee counties should prepare for peak storm surge impacts from Milton.

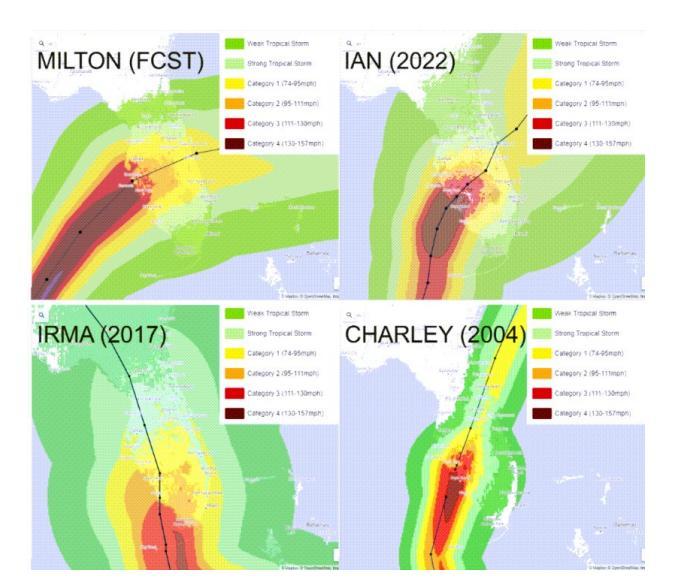
The wind fields of notable west coast Florida hurricanes of the 21st century. Due to the unique aspects of each event, evacuation totals varied significantly across the four events.

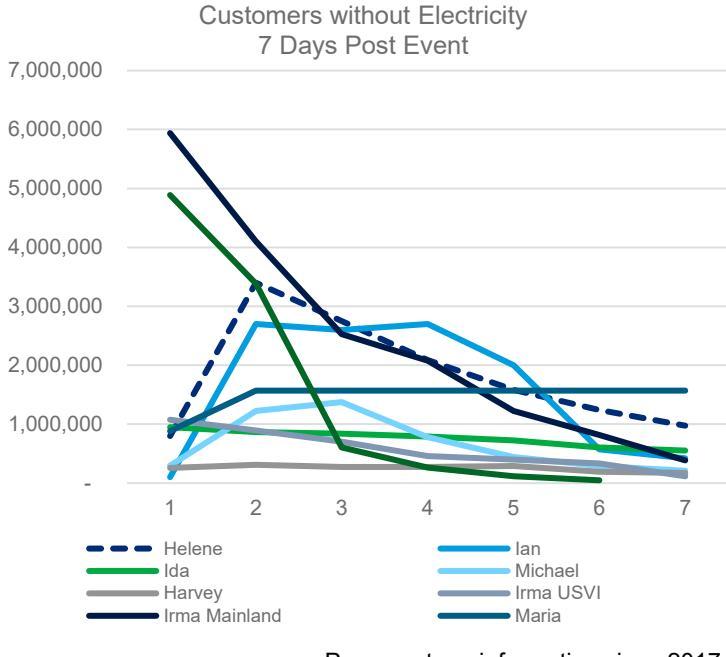
Power outage information since 2017. Source: DOE, Guy Carpenter.

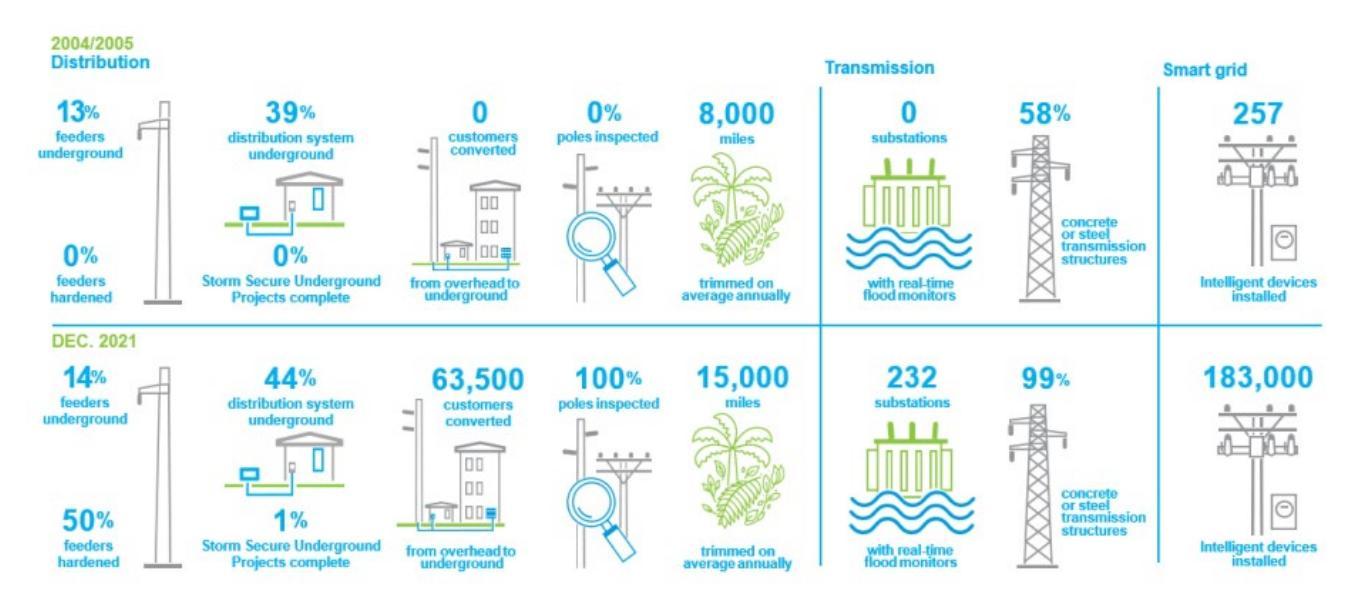
Efforts invoked since the 2004/2005 hurricane seasons to enhance grid resiliency, excludes northwest Florida. Source: Florida Power and Light.

Florida has recently taken steps to improve power infrastructure resiliency against hurricanes, utilizing funding from the Resilient Florida Grant Program. One of the most promising upgrades is the implementation of self-healing technologies that automatically reroute electricity around damaged lines, reducing outage times significantly. During Hurricane lan, these technologies helped restore power to over 160,000 customers and saved nearly 3.3 million hours of outage time. Utility companies have also upgraded thousands of poles and wires and have buried power lines in vulnerable areas. Replacing wooden poles with composites improve strength and flexibility which helps power poles endure storm impacts better without breaking.

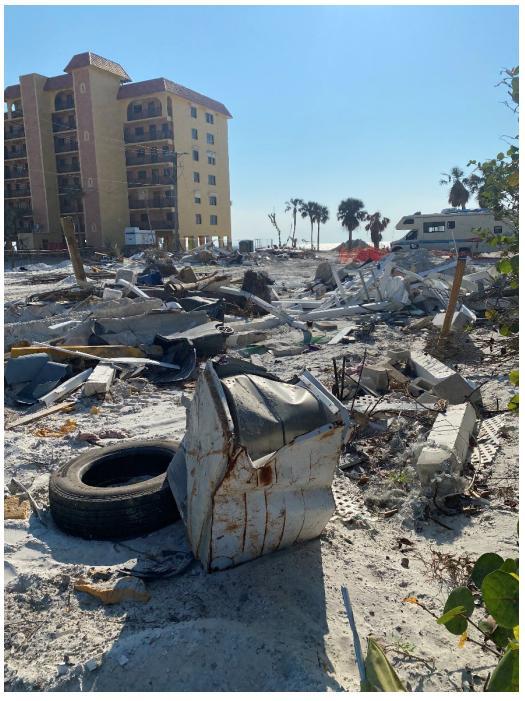
Contents debris on the street side in Fort Myers Beach three months after Hurricane Ian landfall. Source: Guy Carpenter.

A damage multiplier in Hurricane Milton that is a challenge to quantify is the debris left in the wake of Helene. 50% of storm surge damage in Hurricane Helene in September have not yet been cleared from the areas adjoining streets in the region. Given the short time between the 2 storms, a focused effort in the last 72 hours by waste removal and state entities made meaningful progress but was not successful in full removal. Remaining debris significantly increases the risk of wind-borne projectiles and elevated structural damage from floating debris in high velocity surge zones close to the coast.

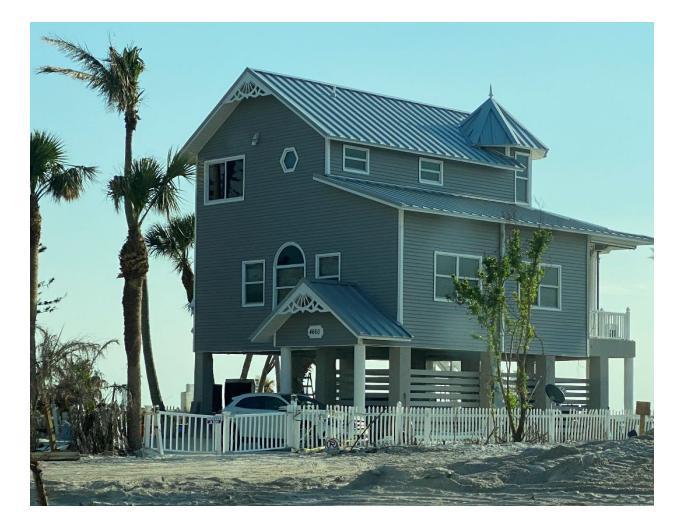
Newer construction of a single-family home in the wind-borne debris region of the most recent Florida building code. Located in Bonita Springs Beach, FL, little wind damage transpired while first floor elevation was above the coastal storm surge. Source: Guy Carpenter.

A Guy Carpenter damage survey on Hurricane Ian (2022) damage revealed mixed impacts from wind and seawater inundation due to storm surge. The areas affected by wind were in the Florida Building Code wind-borne debris regions, with some of the most resilient measures for wind-resistance in the country. Older structures pre-dating these building codes sustained a greater degree of damage with clear damage to roof and even wall materials with clear evidence of rainwater intrusion. Those commercial and residential structures built to more recent codes, particularly post 2004, also showed damage but to a much lesser degree and with fewer cases where the structural envelope was compromised.

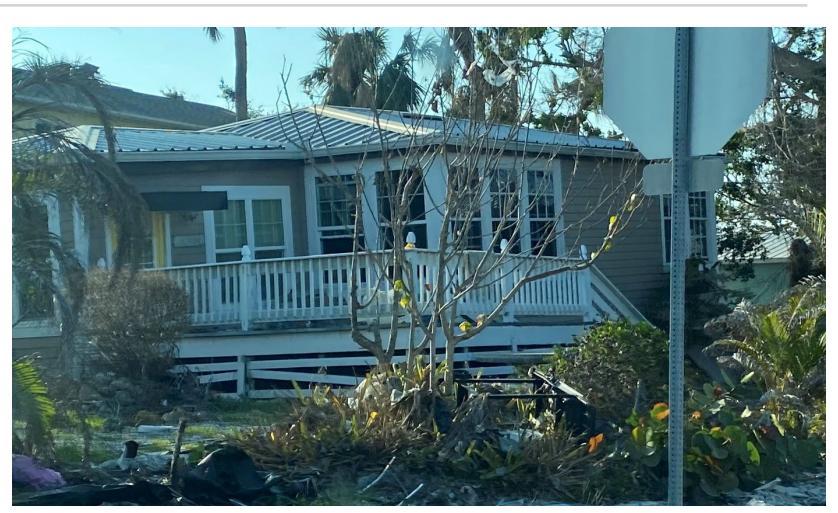
Home damage from storm surge inundation to older construction. Source: Guy Carpenter.

Hurricane lan's storm surge resulted in a broad spectrum of damages. Structures near adjacent waterways were clearly cases where the interior contents, drywall and appliances all had to be replaced, along with treatment for mold and mildew. Closer to the immediate coast, including the Fort Myers Beach area, the damage was most severe from both seawater inundation and wave battering. Engineered structures showed considerable damage to the first and even the second floor, with evidence of wind damage to higher floors. In the meantime, those older structures on concrete slabs suffered catastrophic damage or had completely washed away.

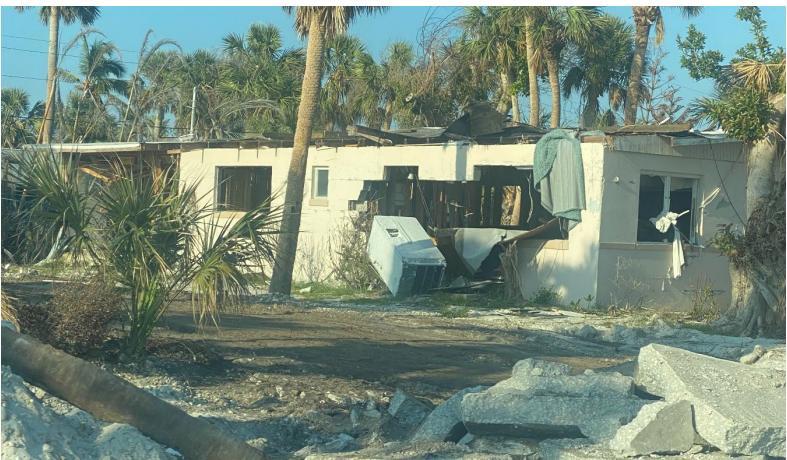
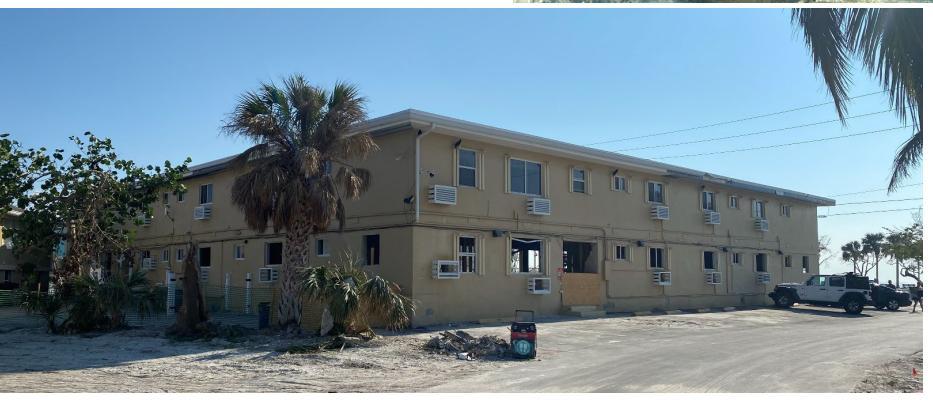
Older construction that endured significant first floor damage due to storm surge inundation as well as roof damage on Fort Myers Beach (above) and on Estero Island, Florida (left). Source: Guy Carpenter.
